## AIRCRAFT ACCIDENT REPORT

UNCONTAINED ENGINE FAILURE  
DELTA AIR LINES FLIGHT 1288  
MCDONNELL DOUGLAS MD-88, N927DA  
PENSACOLA, FLORIDA  
JULY 6, 1996

**Adopted: January 13, 1998  
Notation 6725C**

The National Transportation Safety Board determines that the probable cause of this accident was the fracture of the left engine's front compressor fan hub, which resulted from the failure of Delta Air Lines' fluorescent penetrant inspection process to detect a detectable fatigue crack initiating from an area of altered microstructure that was created during the drilling process by Volvo for Pratt & Whitney and that went undetected at the time of manufacture. Contributing to the accident was the lack of sufficient redundancy in the in-service inspection program.

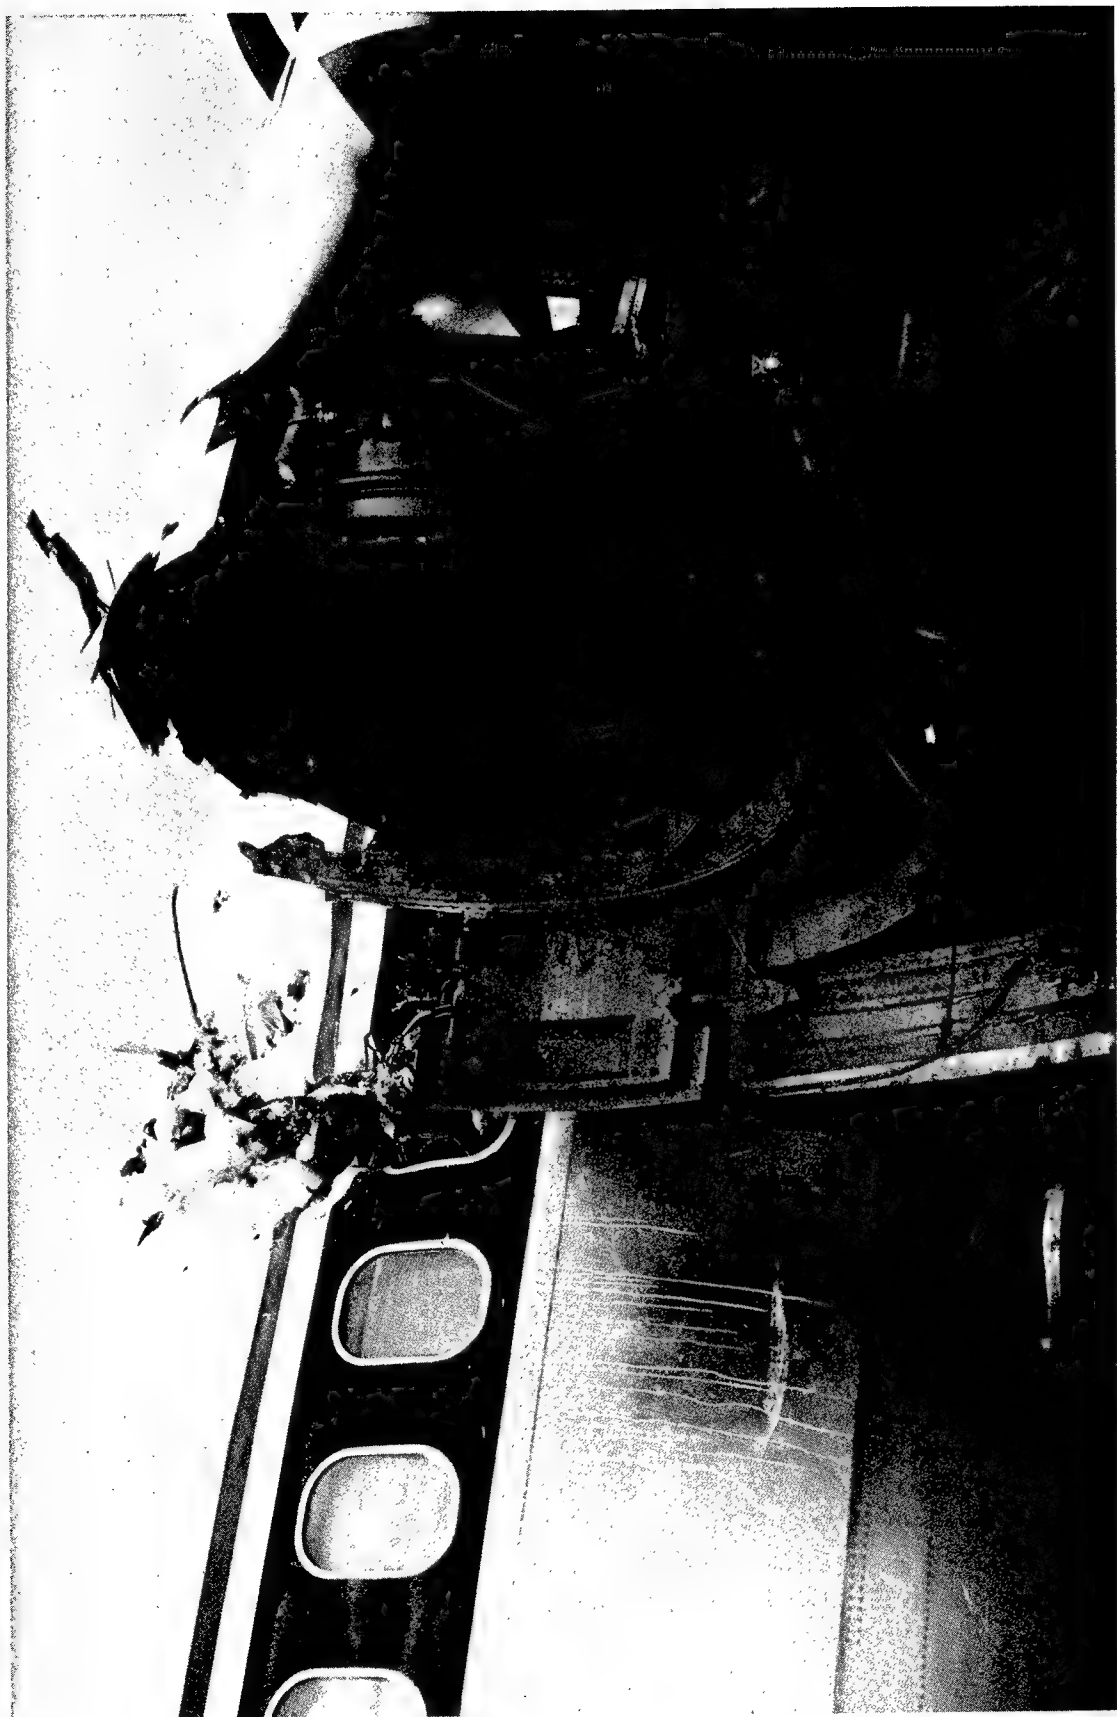
The aft left fuselage and interior of the airplane in the vicinity of the No. 1 engine were substantially damaged by debris from the engine (see figure 1). A total of 16 holes, punctures, or tears were documented on the left fuselage skin. Several large holes and tears were

Figure 1.—Damaged area of airplane near No. 1 engine.

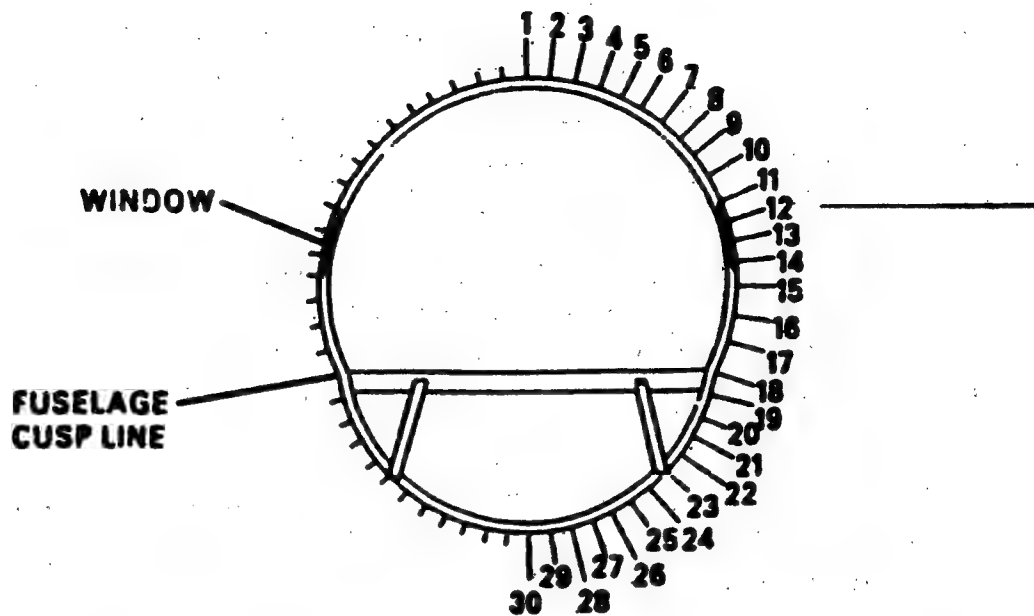
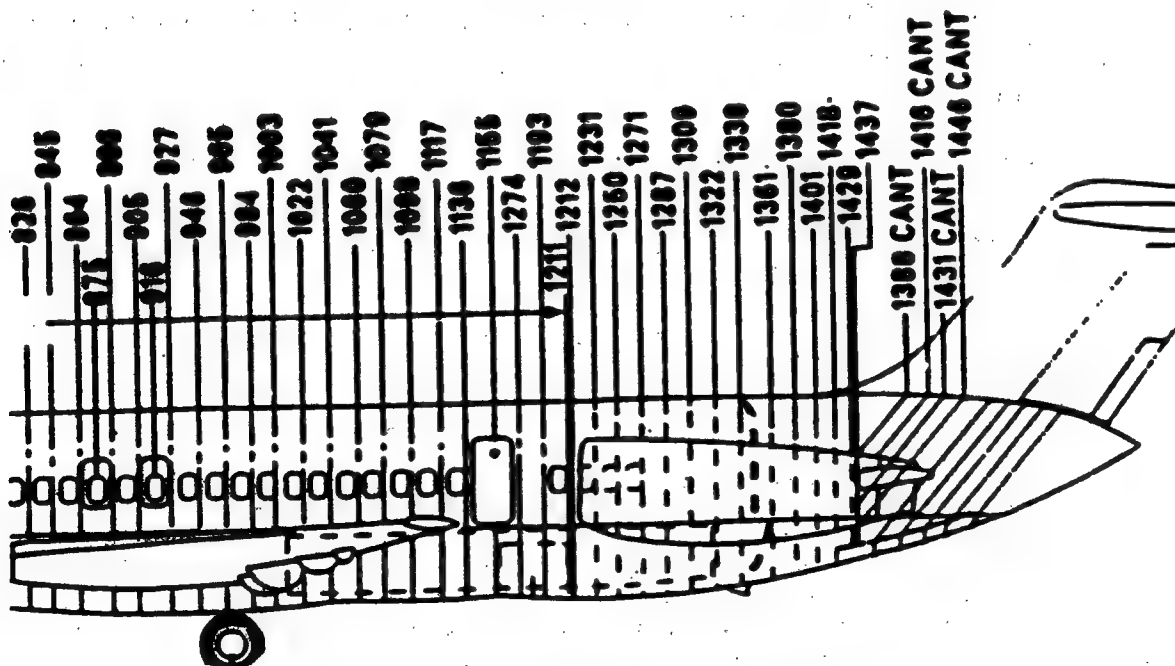
Figure 2.—Fuselage station and longeron identifications.

found between fuselage stations (FS) 1250 and FS 1282 (adjacent to row 37) and from the top of the window to longeron 2 (see figure 2).<sup>12</sup> Seven exit holes, punctures, and tears were documented on the right fuselage skin between FS 1228 and 1271 (just forward of row 37). Most of the wires in the wire bundle located along longeron 4 (on the right side of the fuselage) were severed near FS 1250. Of the 154 wires in the bundle, 146 had been severed. Four of the severed wires were channel differential protection wires that compared incoming and outgoing current for the right generator.<sup>13</sup> No evidence of penetrations existed below the floor level on either side of the fuselage.

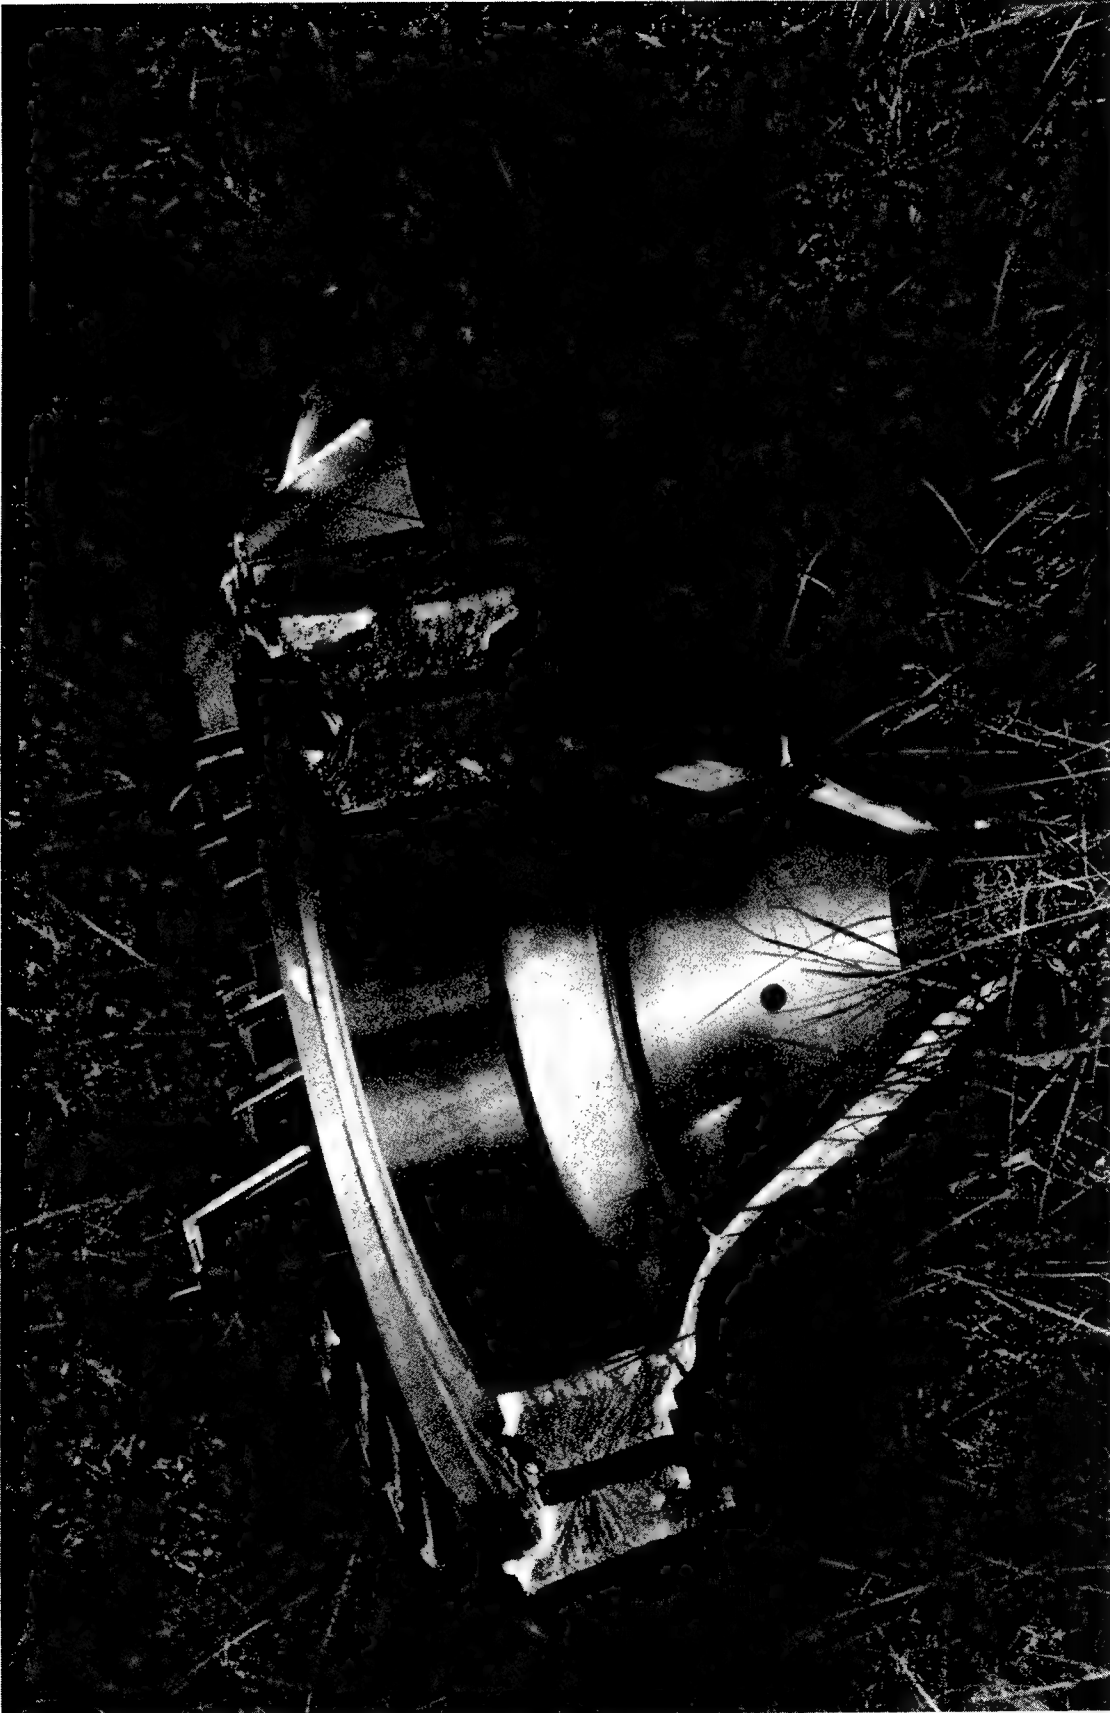
Figure 6.—Two-thirds of hub rim and adjoining conical section.

forward (ALF).<sup>30</sup> A smaller fracture surface was found at the forward section of the conical hub oriented at right angles to the hub axis and extending 360° around the part circumference. The hub rim's fracture surfaces were examined at the accident site by a Safety Board metallurgist and were found to have evidence of fatigue cracking.

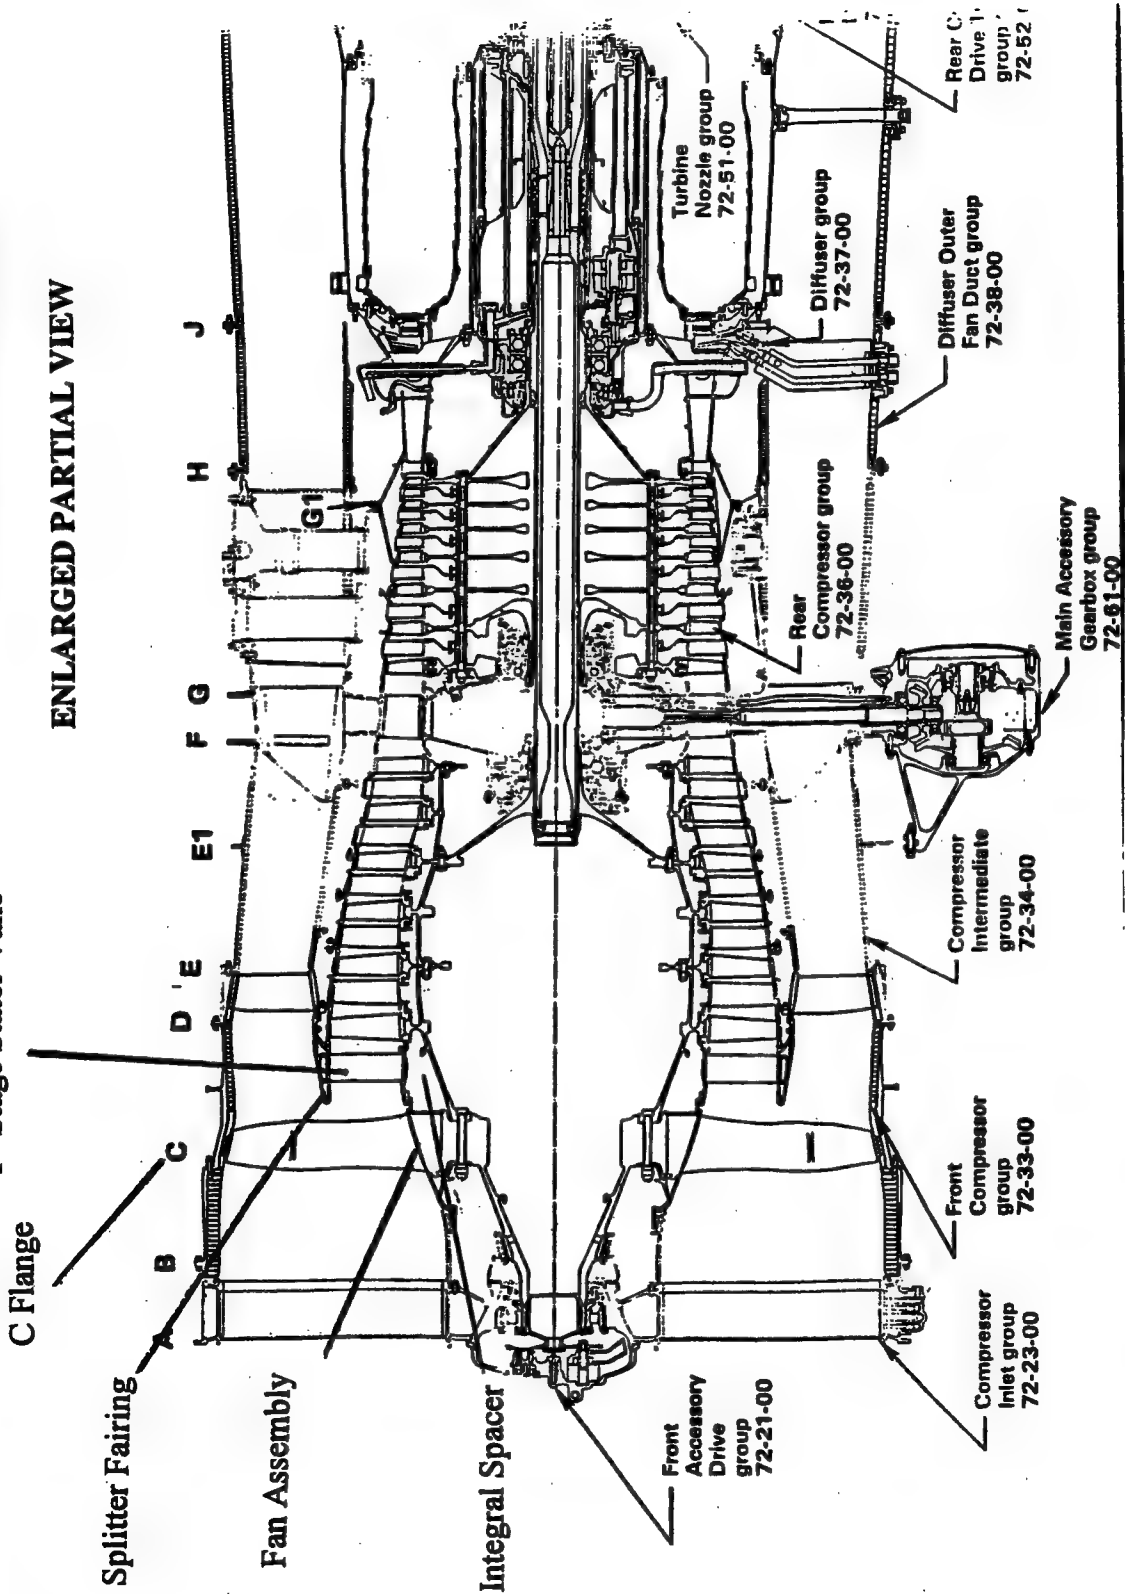
The outer engine case separated at the C flange (see figure 7).<sup>31</sup> Forward of the C flange, the case remained attached to the cowl. The case was torn and fragmented in two areas (centered at the 1 o'clock and 7 o'clock positions) between the C and D flanges. The 1 o'clock position was missing a segment from the 12:30 to 2 o'clock positions. The case was intact but had been torn loose from the D flange between the 2 o'clock and 3 o'clock positions. A 14-inch circumferential part of the fan rear case was found on the runway 61 feet to the right of the centerline and 441 feet from the runway threshold. Acoustic honeycomb in the fan case area was ripped, torn, or missing in many places. The splitter fairing<sup>32</sup> (see figure 7) was missing from the 1 o'clock to the 7 o'clock position. A torn piece of the splitter remained attached at the 5 o'clock position. Twelve first-stage stator vanes<sup>33</sup> were present on the remaining splitter fairing. The inner diameter ends of the vanes were separated from the inner shroud and bent in the direction of rotation.

Figure 7.—Enlarged, partial view of outer engine case of JT8D-200 series engine.

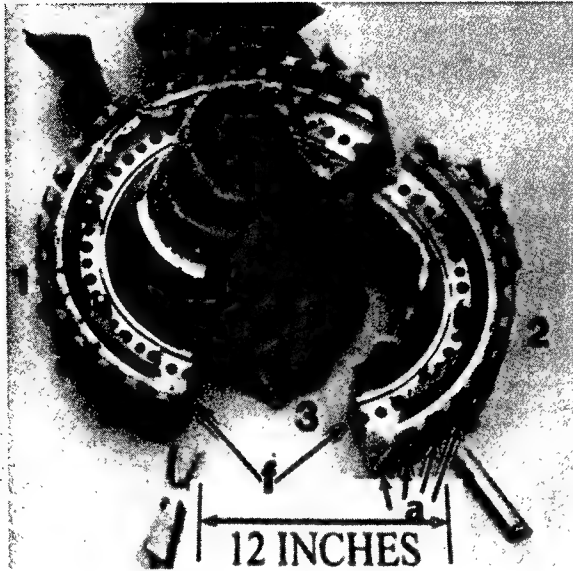
The fan hub fractured through a tierod hole and blade slot. There were two fan blade roots still in place on the small rim segment and 13 blade roots on the larger rim segment. Three of the 13 blades were full length and bent counterclockwise as viewed from aft looking

Figure 9a.—Fractured fan hub.

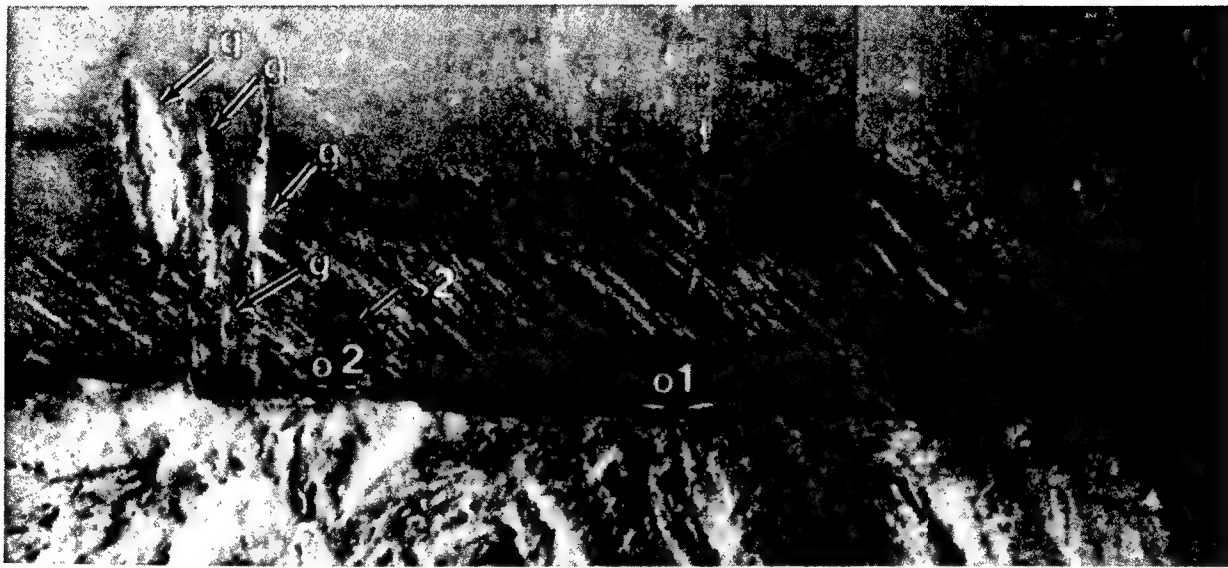
Figure 9c.—Magnified view of fatigue fracture features.
